RAINIER COMMONS - Building Plan

RAINIER COMMONS - Encapsulation and Proposed Abatement Test locations

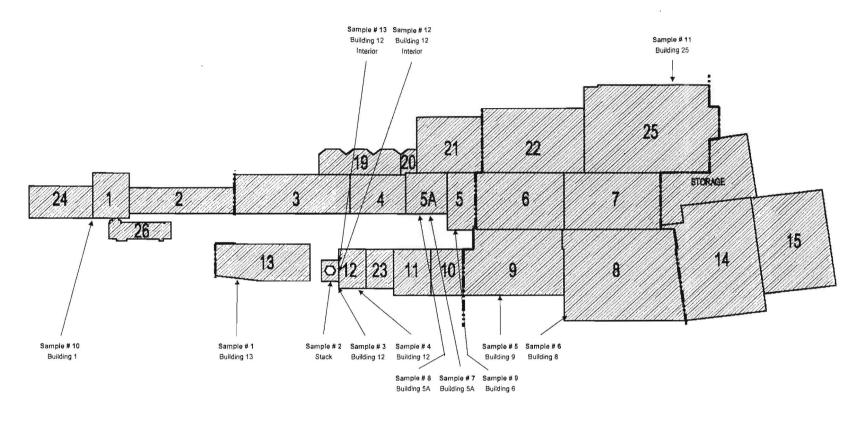
EXHIBIT A fig.1

Paint Samples Taken: 9-1-09

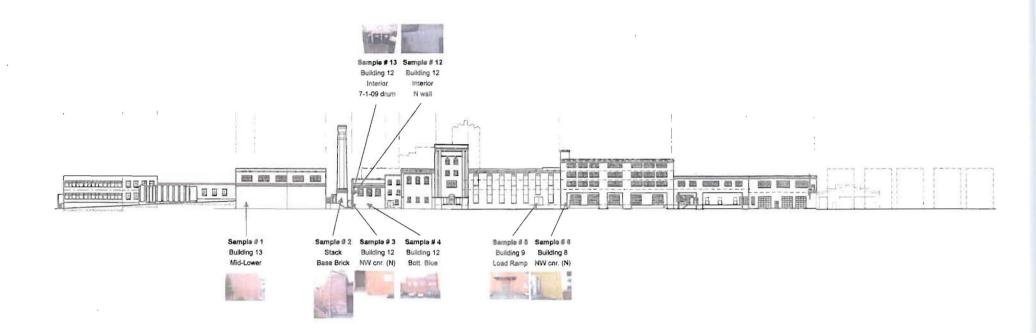
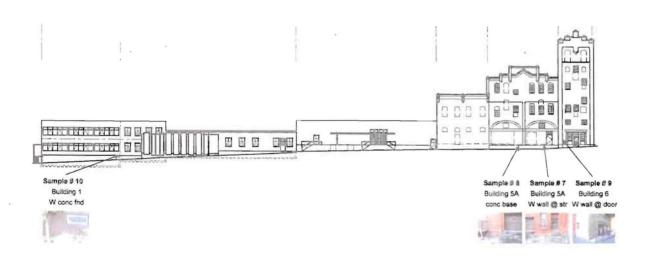
EXHIBIT A fig.3

MANAER COMMONS - West Building Elevation (Courtyard)

RAINIER COMMONS - East Building Elevation (Back Road)
